**Reconnaissance Survey for School WASH
Program in Kandy District**

Draft Report

Report of the Reconnaissance Survey for School WASH Program in Kandy

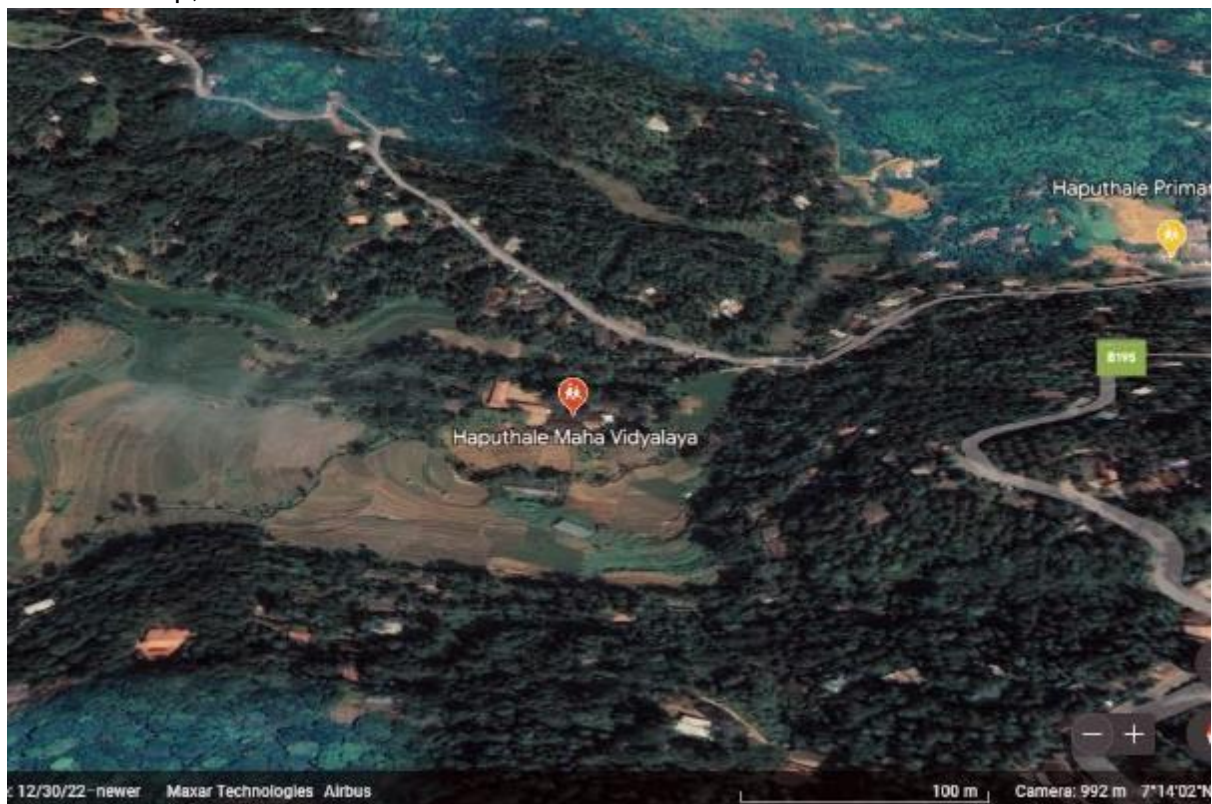
Figure 1 SatMap of Haputhale Maha Vidyalaya

School is located in the Ethulgama road, Thalathuoya, some 4km away from the Thalathuoya town, and it is surrounded by paddy / vegetable lands.

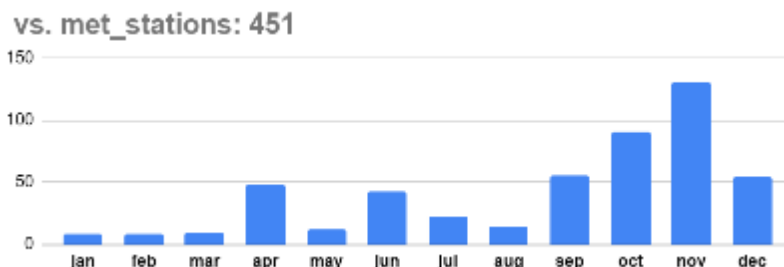
Figure 2 RF Data at nearest RF Station in IM3c agro climatic zone (NLDB Farm, Haragama).

- The Principal was not very enthusiastic about RWH as their daily water consumption is high and they face a very prolonged dry period with no any rain spells between..
- Reference data for the IM3c agro climate zone where the school is located confirms the principal's thoughts. And average rainfall distribution at the nearest RF station located in the NLDB farm is given in the below (Graph & Picture).

- *Picture:*
- Based on high daily water requirement for the sanitation (of about 2000 Lt/ day) and rainfall pattern in the area, a RWH is not a viable option for this school
- Furthermore, school community's preference for deep tube well over a RWH system would make it maintenance of such it not sustainable.

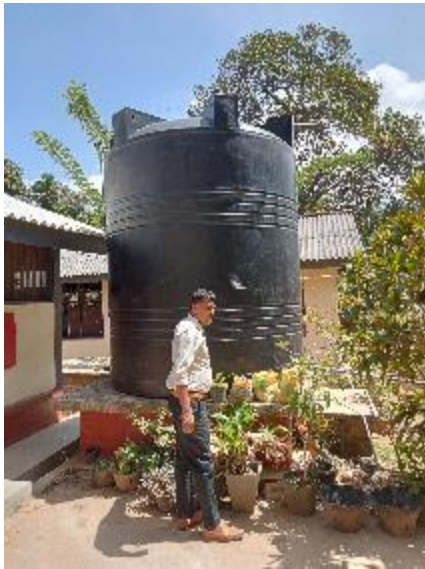
Figure 4 Large Tank to Store Pradeshiya Sabh pipe Water

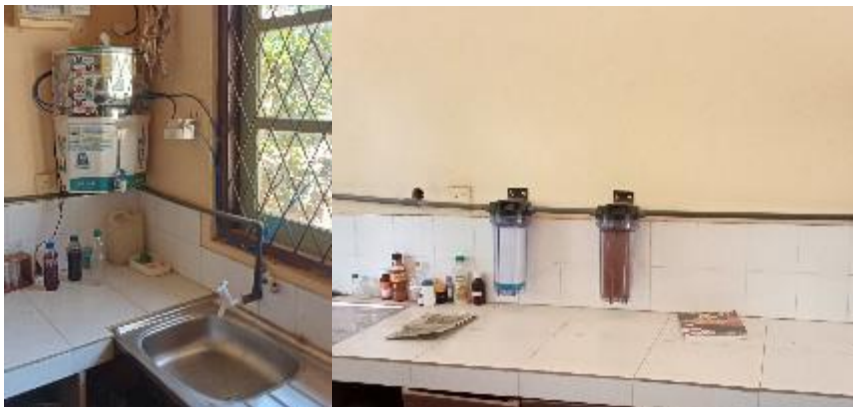
Figure 5 Water Filters for Pipe water

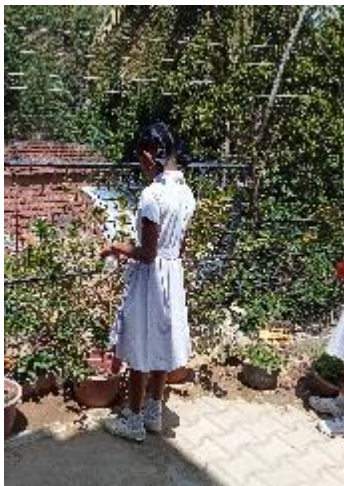
1. Drinking water requirement which is not provided by the school,
2. However, breakfast are providing by the school, water is required for cooking, washing and plates has to wash twice using clean safe water
3. Water for toilet cleaning
4. Water for gardening; no gardening, but students are guided to wash their hands by irritating flower pots that are kept in the corridor (photo).
5. Current water consumption for cooking, washing and toilet cleaning kept below 1000 lt/ day

Figure 8 Water Saving Max

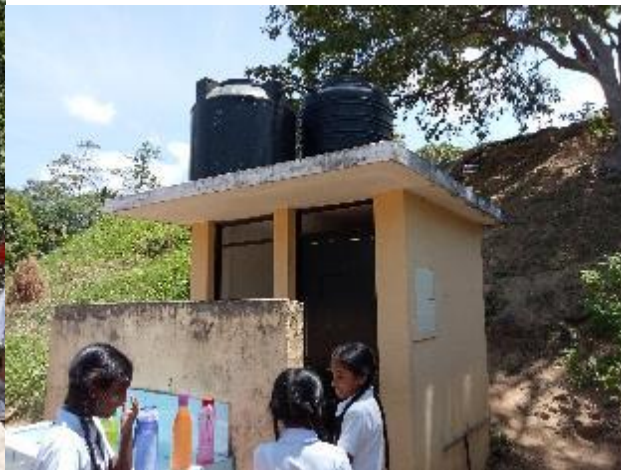
- Students used to walk around carrying their own water bottles with them for safety (photo).
- Some parents are used to delivering additional water bottles during breaks.

Figure 9 Carring Valuble Water Everywhere

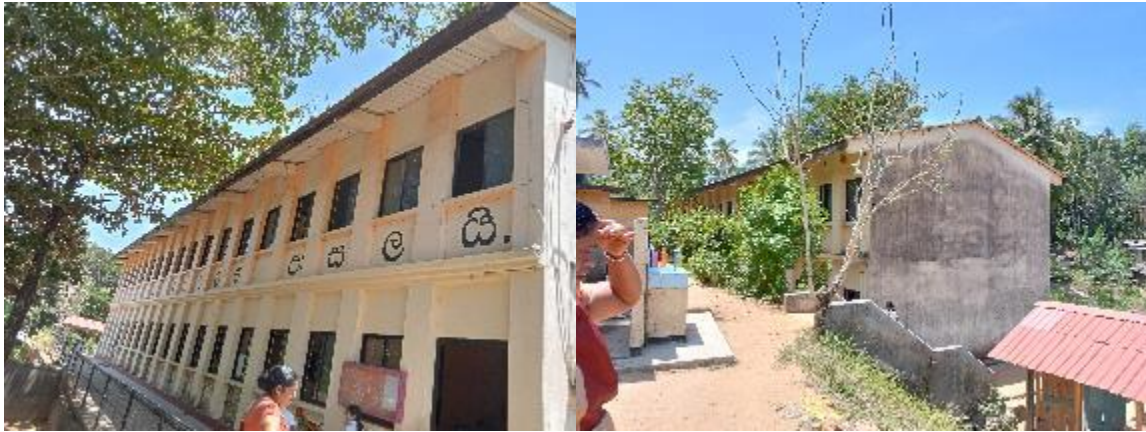
- This also will help to reduce the water bill during the rainy season, which is about 3-4 months year.
- There is only one building in the school, and the roofs (asbestos sheet) is suitable (> 120 ft in length) (photo)
- No guttering, down pipes available,
- Toilets are located at higher ground, hence storage tank location required additional ground preparation, to cut and level about 5fts height, and additional strengthening / support for delivery pipe from roof to the tank across about 15 m. (photo)
- The parents in students' have strong support to the school for soil works involved.

Figure 10 Catchment Roof

School	Priority for RWH	Priority for GWR	Required components	Details/ measurements	Contribution from School
Haputhale Maha Vidyalaya	-	-			
Haputhale Primary School	2	-	Storage Tank (5,000/ 10,000) Gutters (length to match tank volume) Leafs screen/ deflector Down pipe with first flushing Delivery pipe (20m) & support for delivery pipe (galvanize) rapid sand filter distribution pipes (50m) Concrete Basement for the tank Gate valves and pipe fittings	Catchment roof asbestos, second floor of main hall Storage tank location in the edge of school playground, (soil cut and fill work	Labor, soil cut and fill work for concrete basement digging for pipe laying, and support work
Manikdiwela Primary school	1	-	Storage Tank (5,000) Leafs screen/ deflector Down pipe with first flushing Delivery pipe (20m) & support for delivery pipe (galvanize) rapid sand filter distribution pipes (50m) Concrete Basement for the tank Gate valves and pipe fittings	Catchment roof asbestos, second floor of main hall Storage tank location in the edge of school playground, (soil cut and fill work	Labor, soil cut and fill work for concrete basement digging for pipe laying, and support work

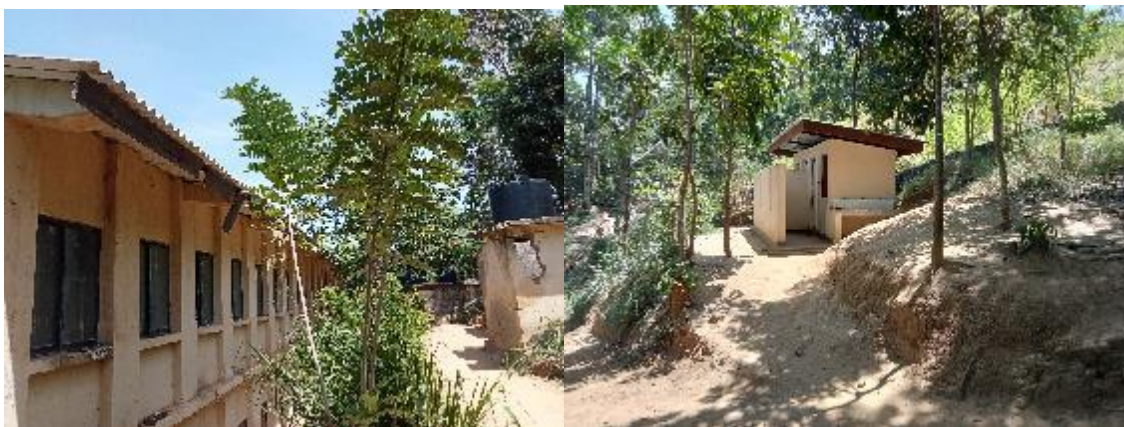
Figure 11 Location for Storage Tank

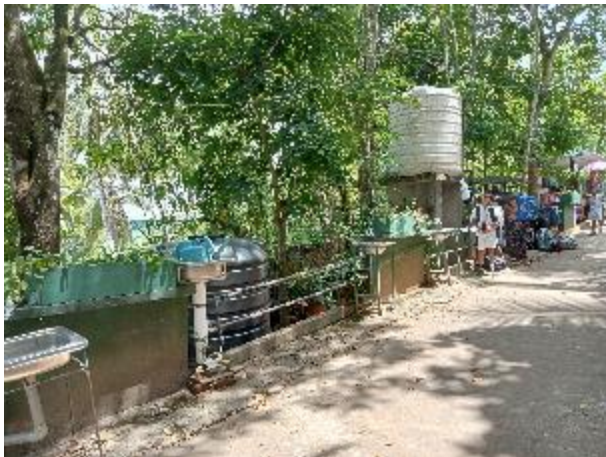
1. Drinking Water; Although almost all students bring water bottles , they used to use more water than that for washing and cleaning after and before meals (up to 2 meals),so they fill up their empty bottles from school water tanks, and some even fill while leaving school” to use while attending evening classes out (photo)
2. Cleaning toilets depends on the availability of water, in tanks, during dry spells water supply to the toilet finishes on the half ways of the day.
3. Usually schools need about 2000 lt/ day for all the uses, and in these drought days receive only about 1500 lt/ day, and there are days not receiving at all. .

Figure 12 Refilling before leaving school

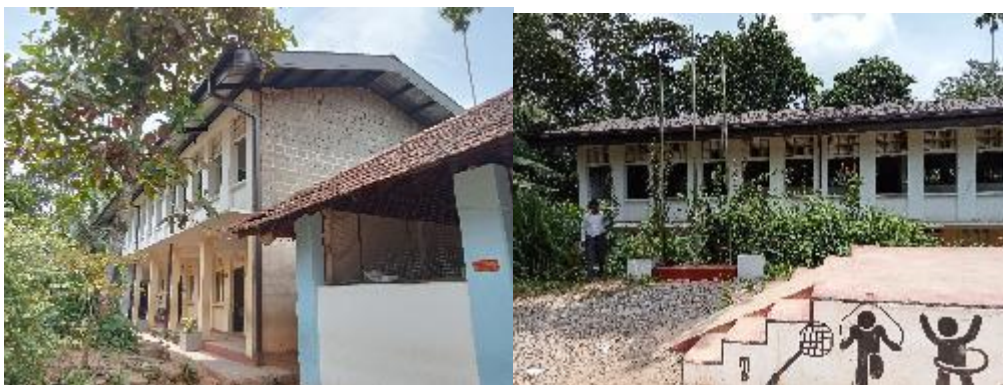
- With prevailing rain patterns in the area RWH is a fully viable option both to provide water for sanitation during dry spells, and in overall reduce high cost for the water bill.
- There is a two story building which is a good catchment for a RWH system,(photo). Which is located some 50m away from the location of the toilet cluster?
- That sheet roof is new, gutters and down pipes fixed, need to trim some shading trees to prevent clogging of RWH system
-

Figure 13 Catchment roof, and location for the tank

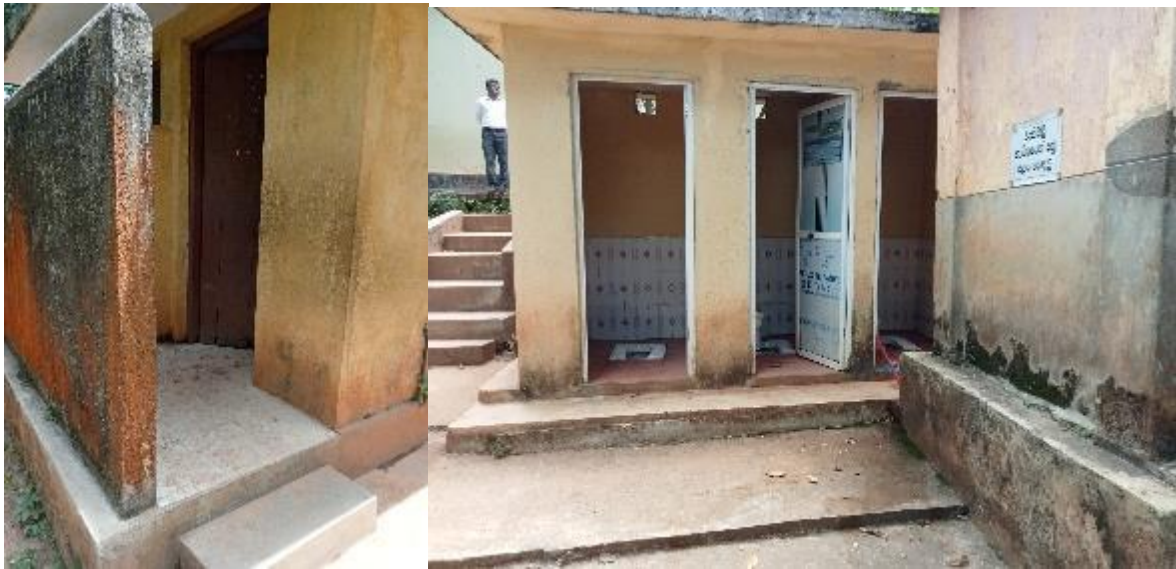
- There are only two toilet units that have a covered door entrance to be used by girls, inadequate at all. It makes long waiting time during breaks.
- Similarly boys urinals have no covering wall behind

Figure 14 Just two toilet units with cover wall, other units with no wall not suitable for girls

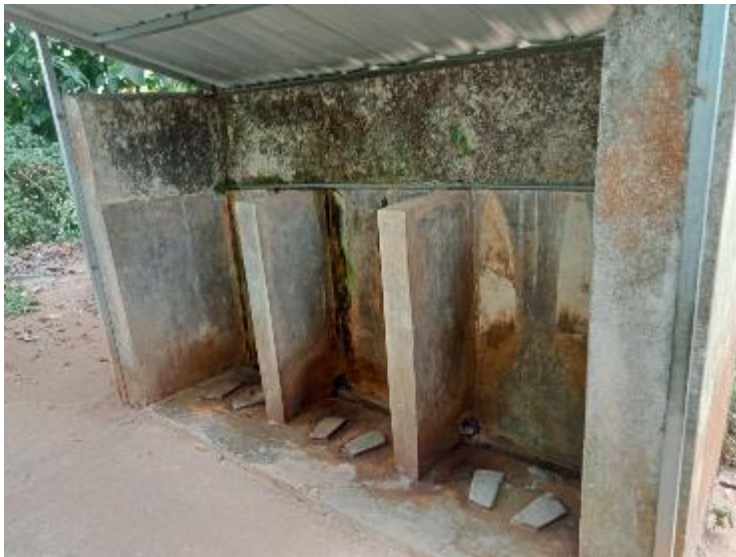
Figure 15 Boys urinals also have no privacy wall

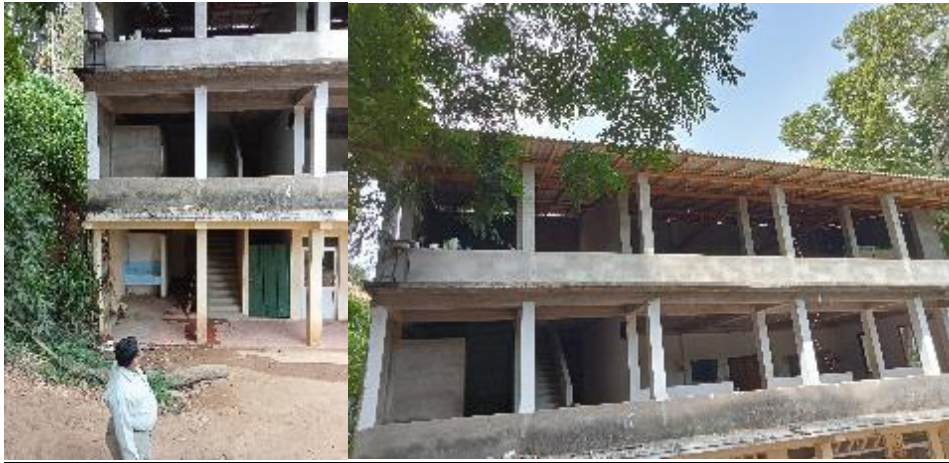
- There is a large catchment roof (asbestos) in the three story building which is unfinished yet,
- It is observed that ground/ soil around new building sandy and unstable. Hill banks not established, very high danger in bank fall, soil erosion.
- So It is recommending to not go ahead before completing construction works and completing and stabilising soil.

Figure 16 Unfinished building, Soil not established, no drainage, danger in erosion
